## 202 E. Hillside Avenue - Contributing

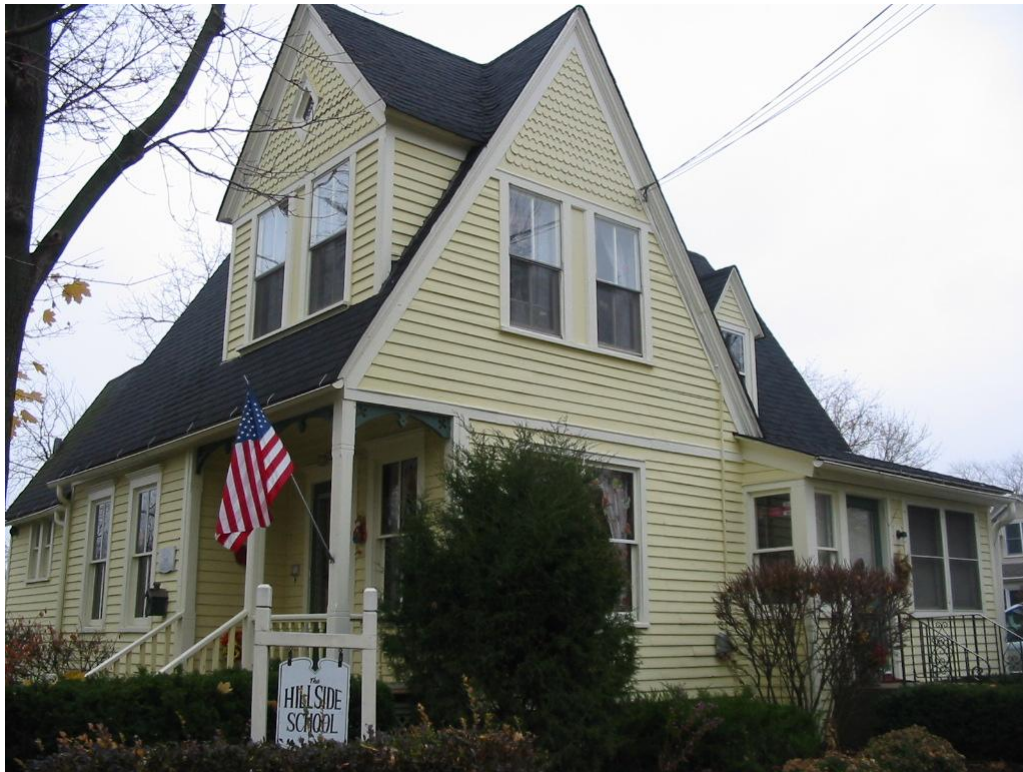
At this location is a one-and a half story, modified gabled ell Folk dwelling built ca. 1886 and extensively remodeled ca. 1930. The house has a steeply pitched gable roof of asphalt shingles, an added concrete block foundation and an exterior of weatherboard siding. On the south elevation is a partial-width shed roof porch that was enclosed ca. 1930-40. The porch has one-over-one double hung wood sash windows, a single-light glass and wood door and a weatherboard exterior. At the roofline of this elevation is a gable roof dormer with one, one-over-one double hung wood sash window. On the east elevation is a gable roof dormer with a multi-light diamond-shaped window. On the west elevation is a small inset entry porch with chamfered wood posts which are connected by a small wooden valence with a central arrow-and-dart drop pendant and clover leaf cutouts. The porch railing has milled balusters. The main entrance is located on this elevation and has a ca. 1970, glass and wood door with louvered glass. The windows on the dwelling are primarily original two-over-two wood sash.

At the roofline of the west elevation is a gable roof dormer with paired, two-over-two double hung wood sash windows. In the dormer's gable field are wood shingles of various patterns and a central diamond shaped attic window. On the north elevation are two, original gable roof wings. The westernmost wing has a small shed roof porch on its east elevation with chamfered wood posts. This wing also has a diamond-shaped attic window on its north elevation. There are two, small one-over-one double hung wood sash windows on the west elevation. The house has an interior brick chimney that appears to be rebuilt.
